RE: Site Inspection, Jason Shumway, Picture Rock Quarry, S/037/099, San Juan County, Utah

Date of Inspection: March 27, 2003  
Time of Inspection: About 12:15 to 12:35 p.m.  
Conditions: Mostly clear, 30's  
Participants: Ted McDougall (BLM) and Paul Baker (DOGM)

**S/037/099, Picture Rock Quarry, Jason Shumway**

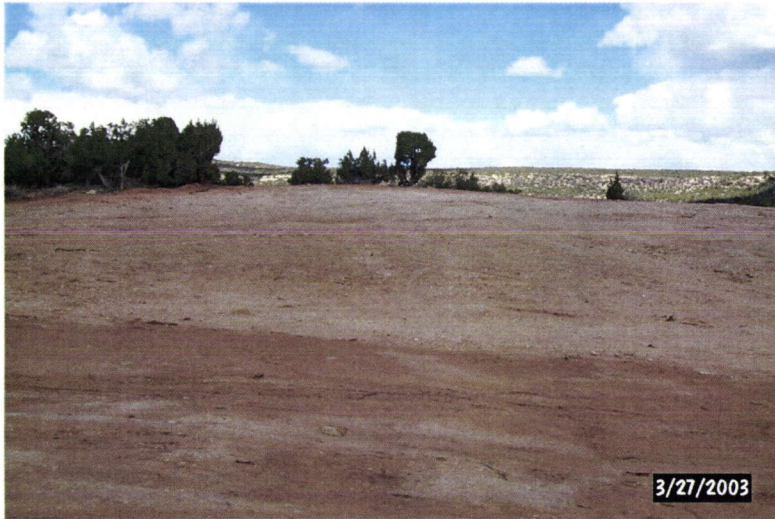
**Photo 1. Part of the graded area.**

A portion of the site is basically reclaimed except for seedbed preparation and seeding (Photo 1), but the operator is still taking some stone from parts of the site nearest the road (Photos 2 and 4). Part of this area is in something of a depression.

The part of the site that has been regraded looks good. As the operations wind down, the operator will need to continue grading the site to make it blend with adjacent areas. Unless the Bureau of Land Management decides it would like the existing depression (right side of Photo 4) to remain as a watering structure, the remaining active quarry area should be graded so it has positive drainage leading off the site. Some of the material that was pushed to the side by the county could be used as fill for this area.

I understand the operator is trying to complete reclamation by a May 1 deadline; however, I recommend that the operator complete basic grading this spring then scarify and seed the area in about October. Seeding in the late spring is not likely to be successful. Seeding should follow scarification as soon as possible.

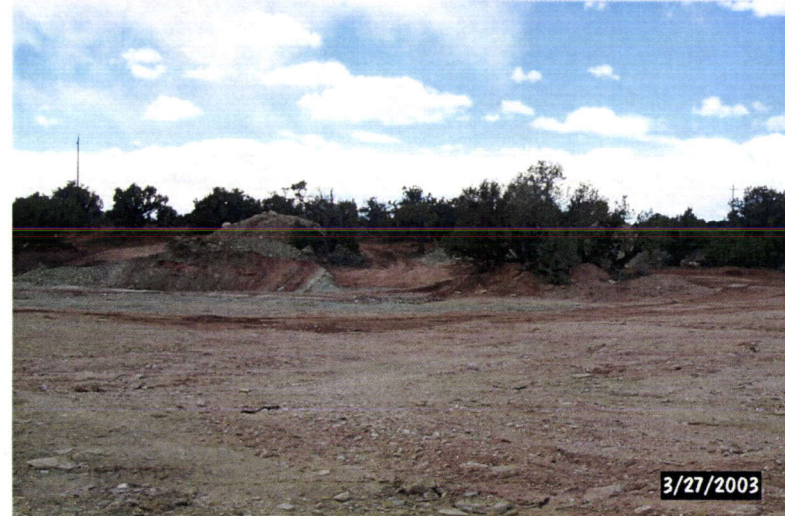
**Photo 3. Material stockpiles at the side of the disturbed area. This material might be used to fill the depression on the right side of Photo 4.**

Mr. McDougall explained to me that before this was a quarry, the county used much of the material near the surface for building roads. There was some material scraped to the side (Photo 3).
